Property Inspection Report

1234 Main St, Anytown CA, 92345
Inspection prepared for: Mr & Mrs Buyer
Agent: No agent involved -

Inspection Date: 1/1/2009 Time: 10:00AM
Age: 35 years Size: 2000

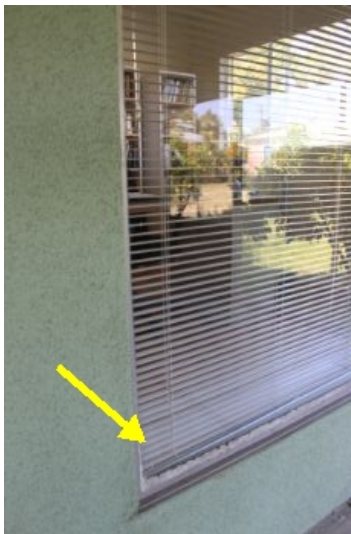
- Window glass cracked at large window in office. This window has NO indication that it is safety glass. By modern standards a window of this configuration would call for tempered safety glass. This is a safety concern.
- North window in living room does not fully latch.
- Window above bath tub is not labeled as safety glass. French doors should also be safety glass.

Window glass cracked at large window in office. This window has NO indication that it is safety glass. By modern standards a window of this configuration would call for tempered safety glass. This is a safety concern.

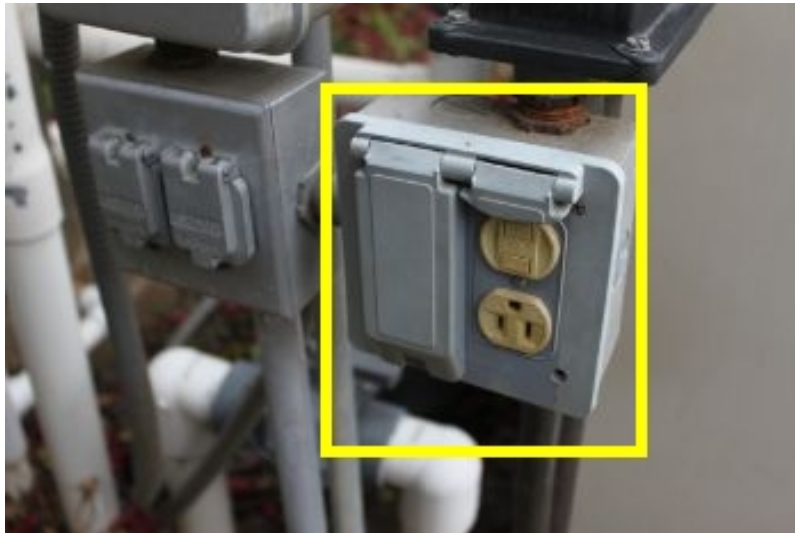
water-resistant cover missing on exterior electrical receptacle

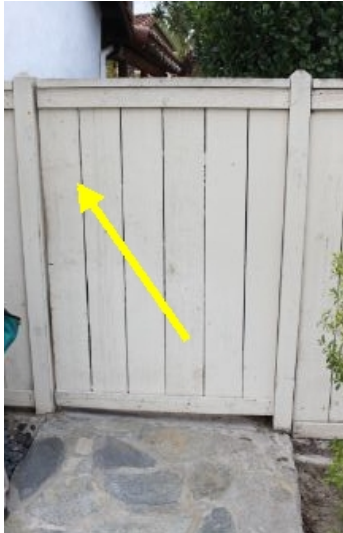
- Fences and gates are NOT INCLUDED as part of a home inspection, recommend confirming that all fences and gates are in serviceable condition before the close of escrow
- Gates that lead to swimming pools must swing away from the pool area. This is to ensure that a child cannot gain access to the pool simply by leaning on an unlatched gate.

Gates leading to swimming pools should swing away from pool area

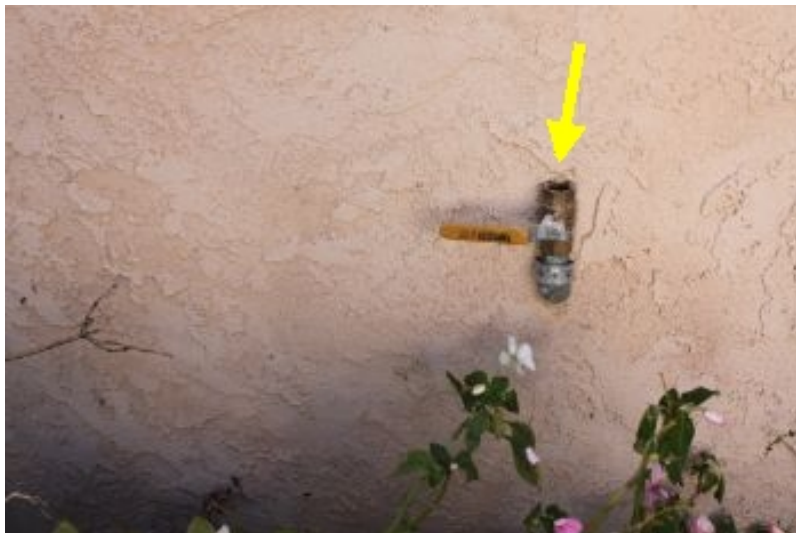
- For any suspected gas emergency, or questions regarding a gas odor or carbon monoxide, please call SDG&E immediately at 1-800-411-7343
- A gas valve located on the north side of the house is uncapped. This presents a safety hazard.

Uncapped gas valve presents a hazardous condition

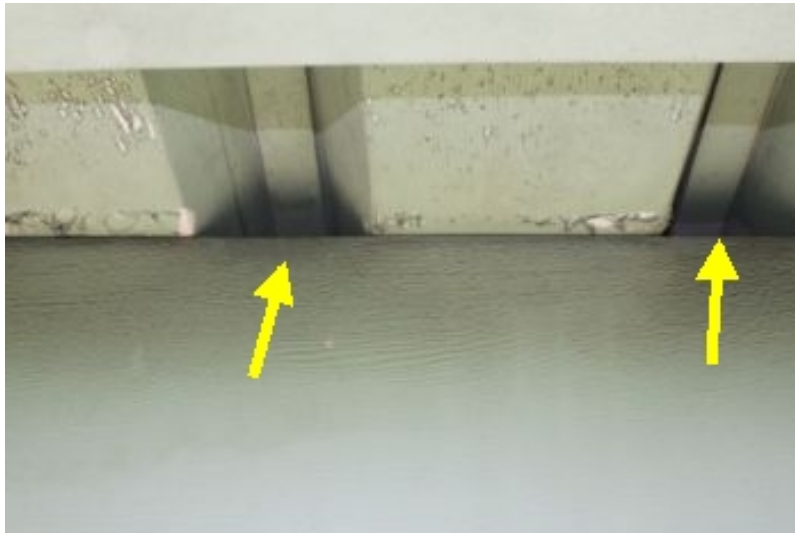
- Rotted Wood visible on interior paneling
- Signs of water intrusion in sunroom / patio

Some places are missing insulation / birdstop under sunroom roof.

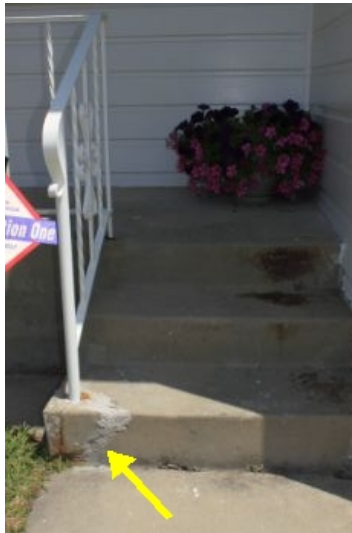
Front porch handrail has a broken concrete at base, and its baluster are spaced more than a safe distance and handrail is shorter than the recommended height.

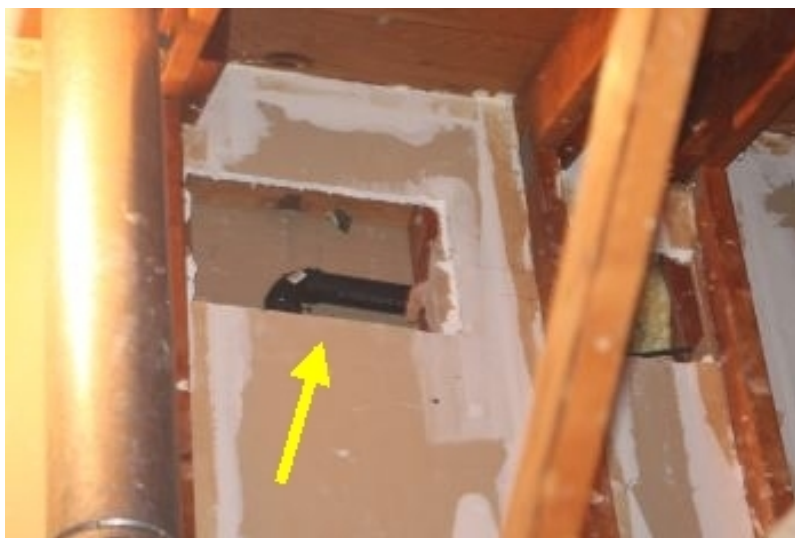
- The common wall between the garage and home has plaster damage and several openings. Any opening in the firewall ought to be sealed to prevent fire from rapidly spreading from the garage to the house.
- Personal items in garage block complete inspection of all floor, wall and ceiling areas.

The common wall between the house and garage is a firewall. No openings should be permitted.

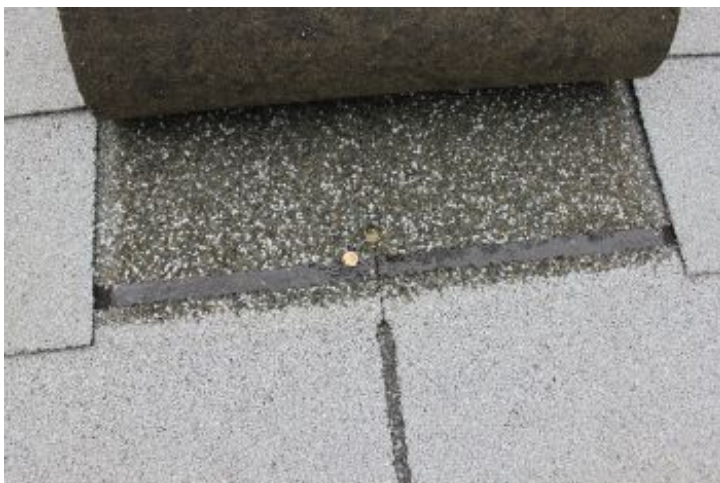
The nailing configuration of shingles are largely not visible, however, some irregularities were noted.

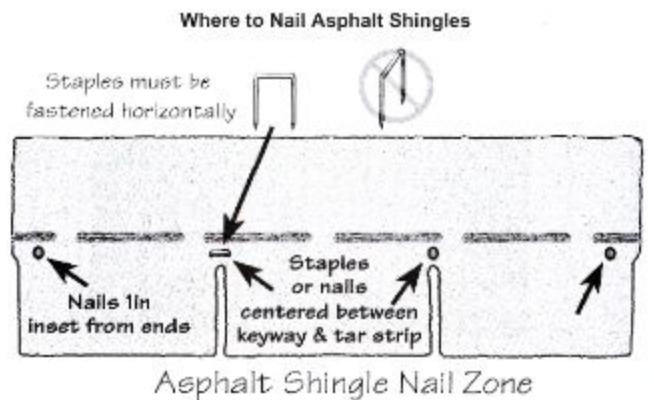
- If the roof is fastened properly, each shingle is getting two rows of nails (total of 8 per each 3-tab shingle).

Nails should be below tar strip

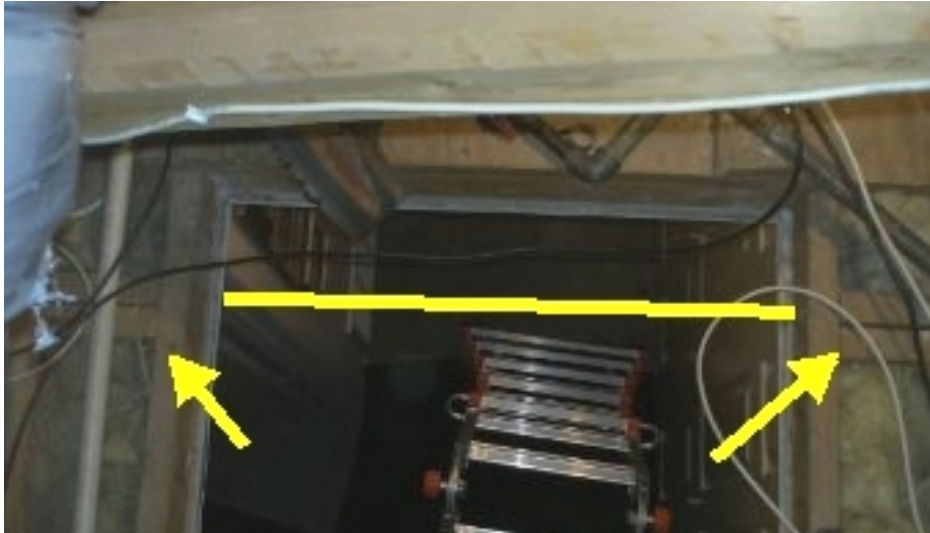
- Roof truss was cut to accommodate a large access door. Roof trusses are not permitted to be altered without engineering.

Roof truss bottom cord has been cut out. Alterations to trusses are not permitted without engineering.

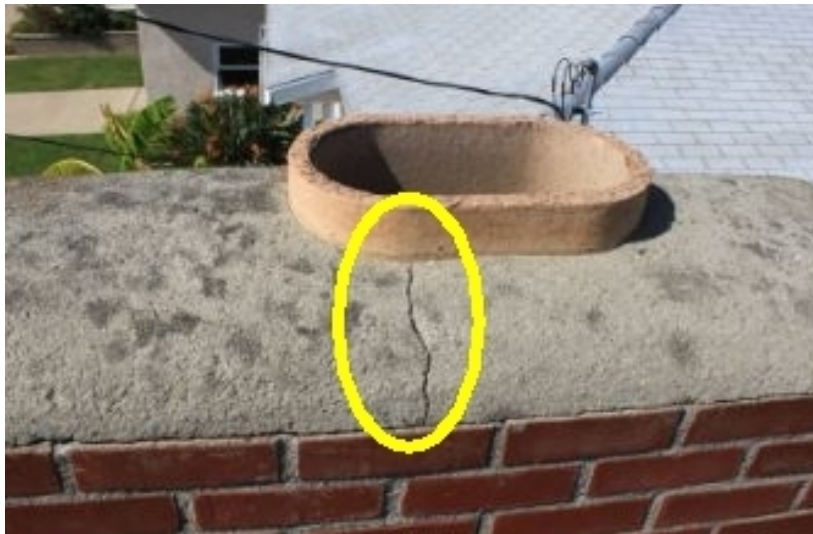
Crack in chimney crown should be sealed

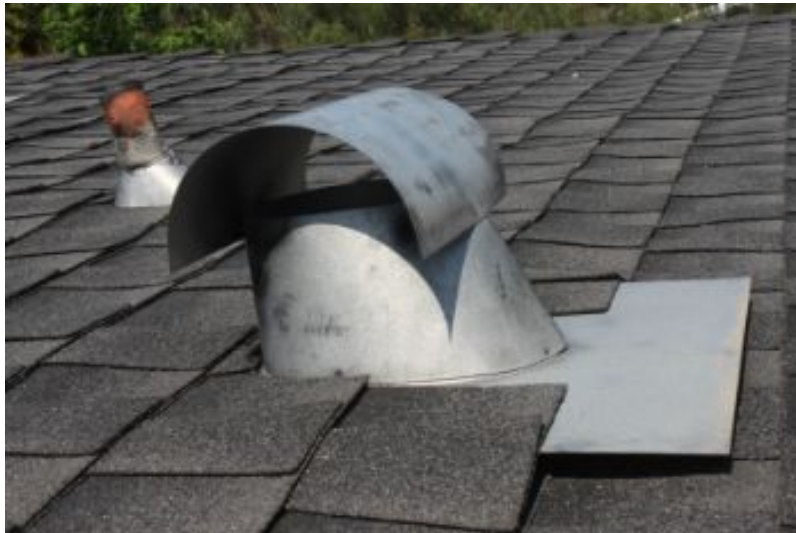
The vent cap over the kitchen is lifted off the roof and might allow water to enter.

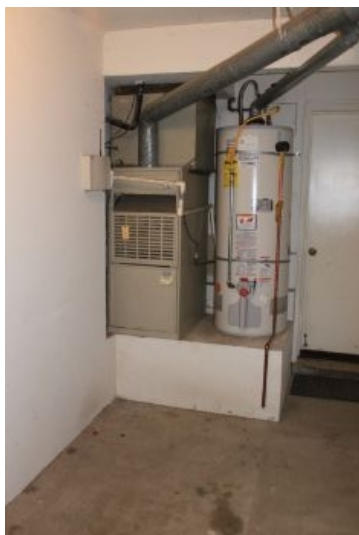
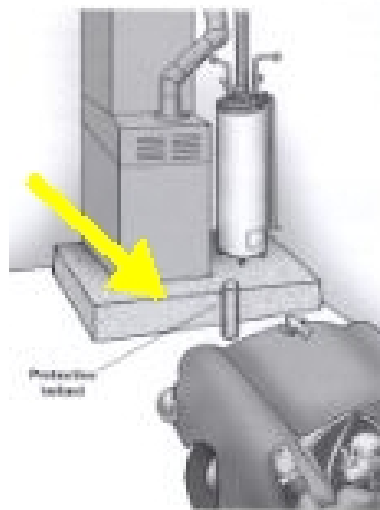
Water heaters in garages should be protected from vehicle impact

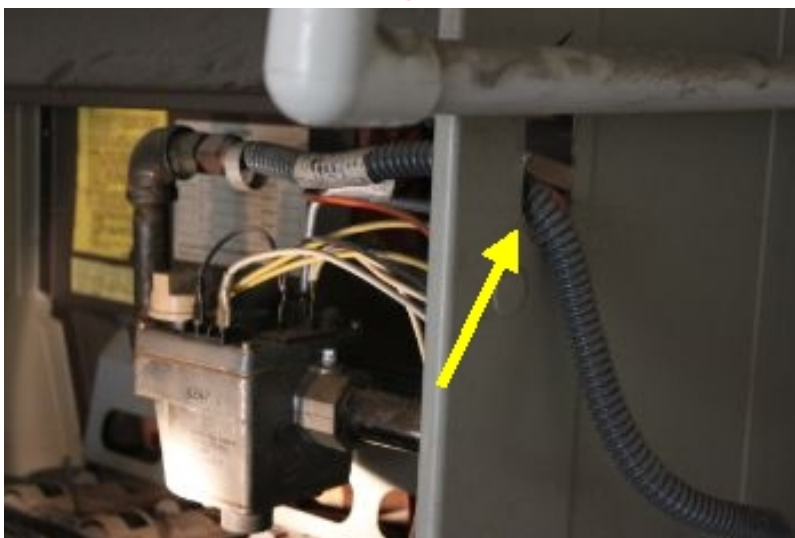
Solid Gas piping should penetrating the cabinet rather than flexible tubing

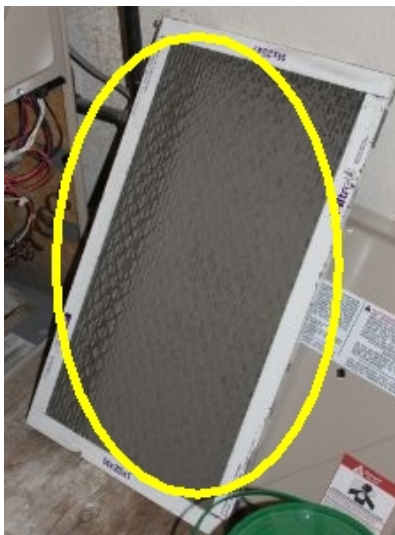
Air filter needs to be changed regularly

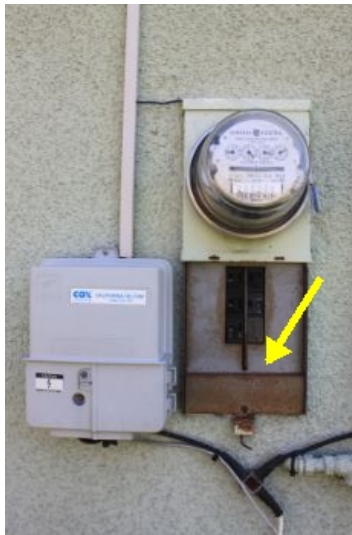
Rust present - evidence of water intrusion

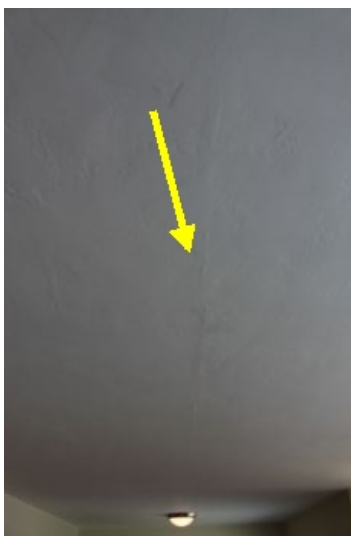
Evidence of a crease / crack in the ceiling was noted in several areas.

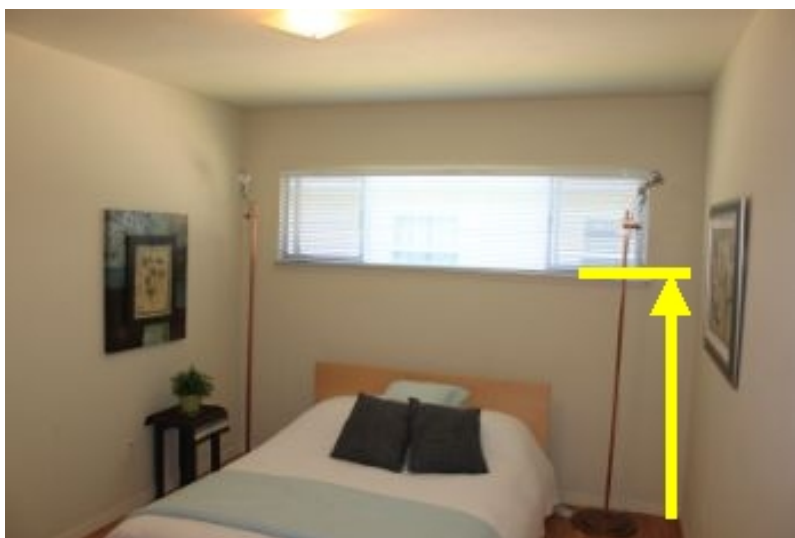
- Window in bedroom do not allow sufficient opening for exit in the event of an emergency. Current building standards call for window sills no higher than 44" from the floor.

Standards call for a max window sill height of 44" off the floor in order to allow secondary emergency egress.

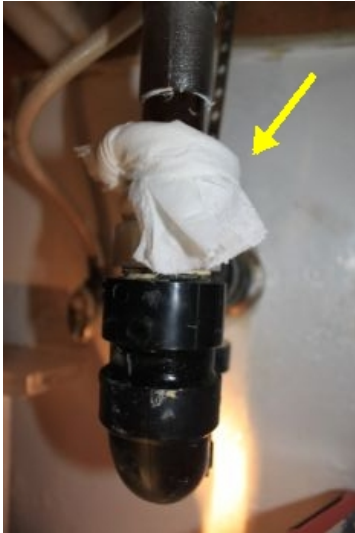
Drain line leaks under sink. Small leak at hall bathroom sink.

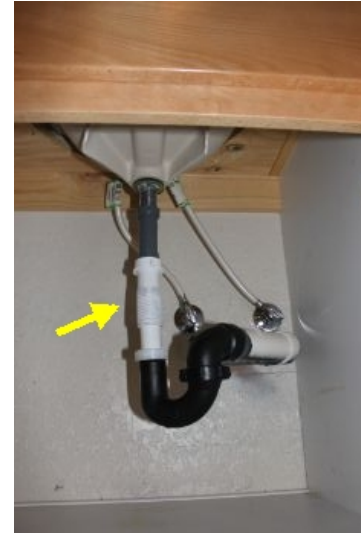
Flexible tubing is a non-standard material for this application

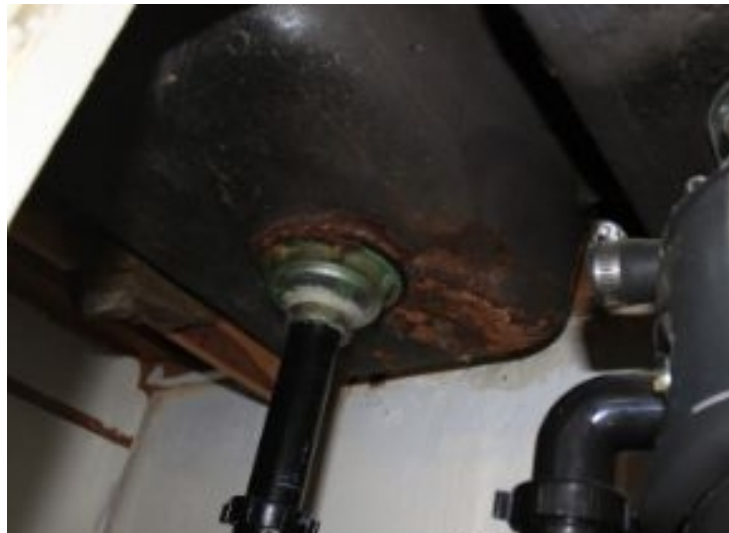
Rust at underside of sink

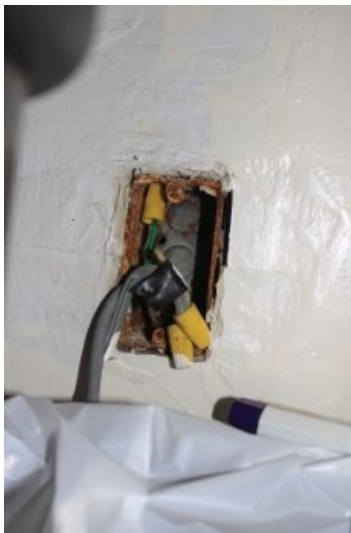
Junction box missing cover and wires are exposed.

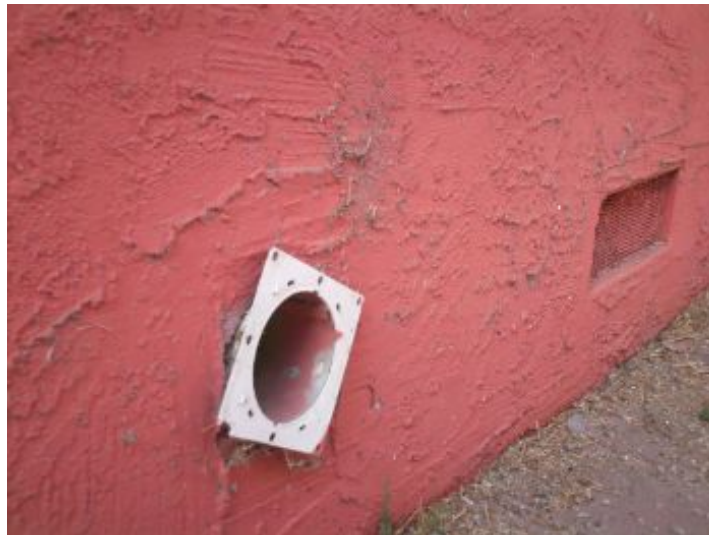
Dry vent missing screen and damper

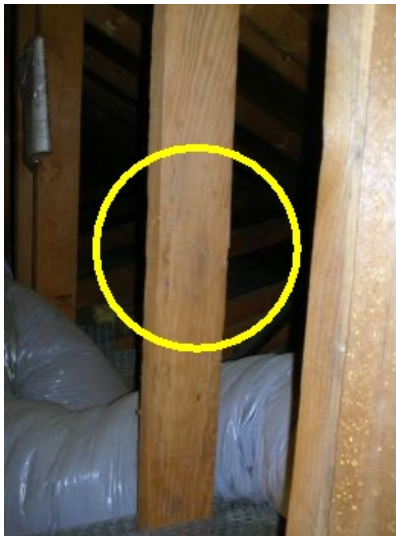
- Could not access all areas of the attic due to limited space.
- Assessment of attic greatly limited by blown-in insulation.
- Broken truss kingpost was noted

King post of truss is cracked. Repair recommended.

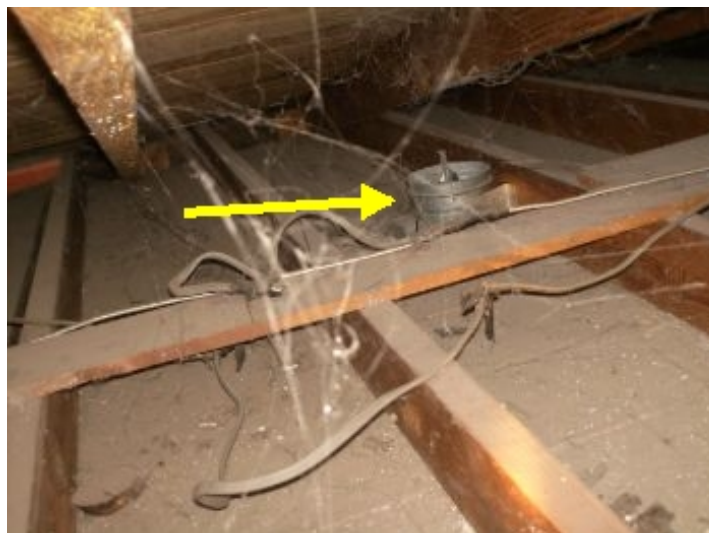
Bathroom vent terminates in attic rather than venting to exterior

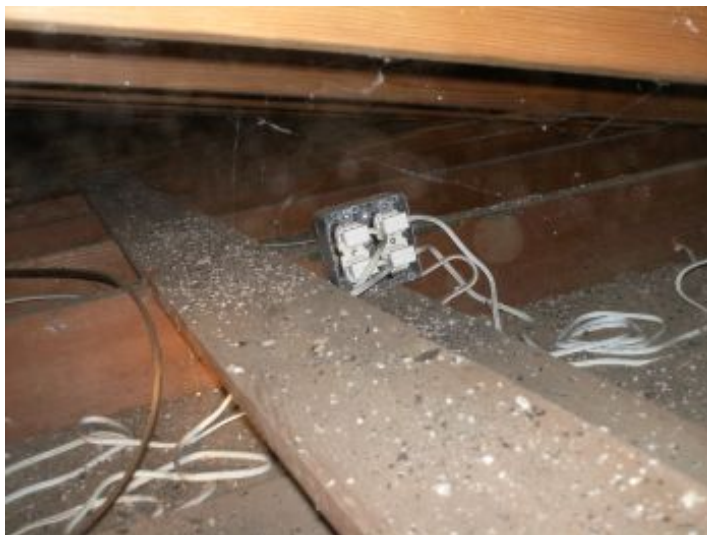
- Unprotected wires are within 6 feet of access opening and have trip hazard potential. These wires should also be protected from possible damage.
- Electrical wiring for bedroom closet lights are sub-standard.

Open receptacles & non-standard wiring installation are present in the attic

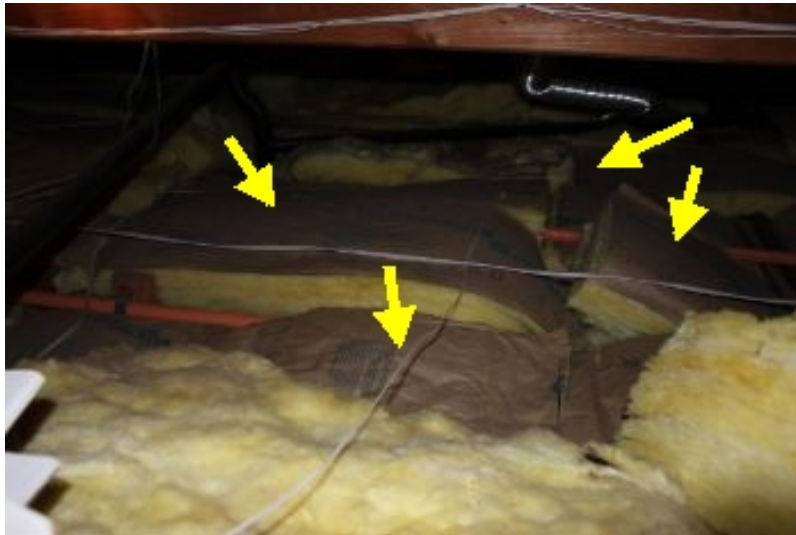
- Vapor retarder/barrier installed wrong side up

Insulation is installed upside down in area over front bedroom
